Manhole Inspection Summary

Manhole # S01EE2008MH

Insp Date: **7/21/06 8:16 AM**

Location Address: **6417 Western Run Dr**

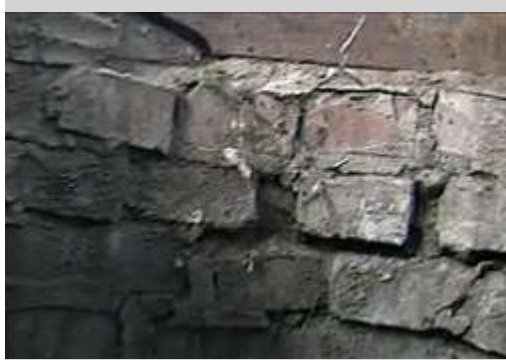
Defect

Condition: ☐ Sound ☐ Cracked ☐ Root Intrusion ☒ **Loose Brick** ☐ Deteriorated

Infiltration: ☐ None ☒ **Joint** ☐ Cracks ☒ **Mortar** ☐ Roots ☐ Wall

loose/cracked bricks in adjustment section

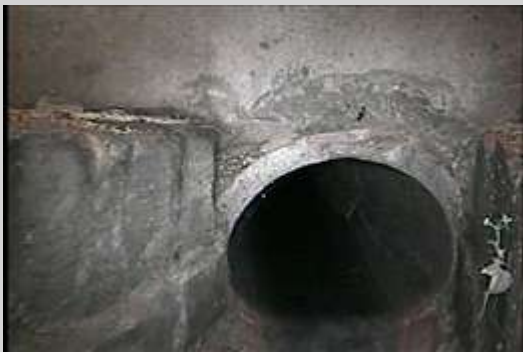
8 in. Circular Gravity Sewer Pipe Out @ 12 O'Clock

Deposits: ☒ None ☐ Mud ☐ Sludge ☐ Debris ☐ Grease

Infiltration: **None** Pipe Seal Cond: **Sound**

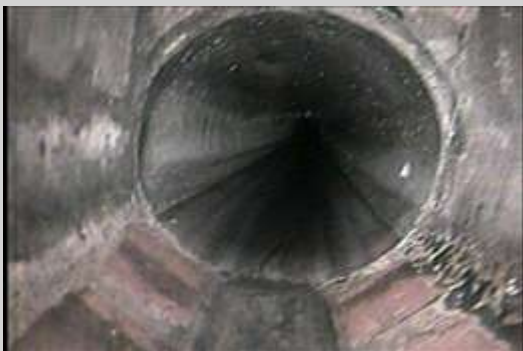
8 in. Circular Gravity Sewer Pipe In @ 7 O'Clock

Deposits: ☒ None ☐ Mud ☐ Sludge ☐ Debris ☐ Grease

Infiltration: **None** Pipe Seal Cond: **Sound**
